**Flood Control Project Maintenance
Levee Inspections**
LMA District Cover Sheet
Spring 2011 Levee Inspection Results

Lower San Joaquin Levee District

Spring 2011 Levee Inspection Results

Waterway			Bank	Unit Miles
Unit No. 01 San Joaquin River			Right	22.56

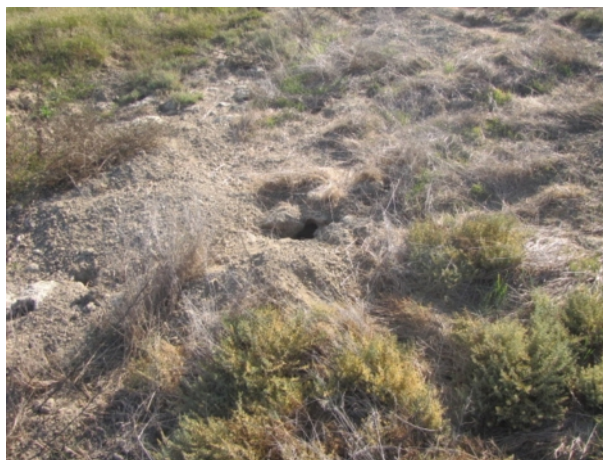
richard_s_20110215_074.jpg

Typical view of squirrel burrows in this section of levee

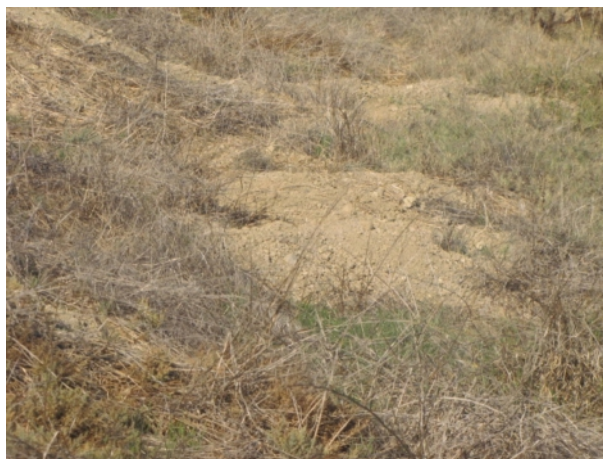
richard_s_20110215_075.jpg

Levee Mile Report Line	5
Start Levee Mile	3.72
End Levee Mile	3.74
Location	Land Side
Category	Earthen Levee
Item	Animal Control

Looking at typical view of squirrel burrows on landside slope in this section of levee.

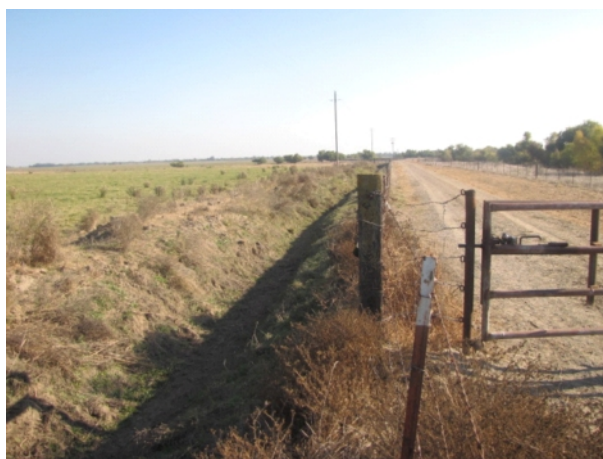
richard_s_20110215_076.jpg

Levee Mile Report Line	6
Start Levee Mile	4.00
End Levee Mile	4.08
Location	Land Side
Category	Earthen Levee
Item	Encroachments

Looking south at irrigation ditch along landside toe.

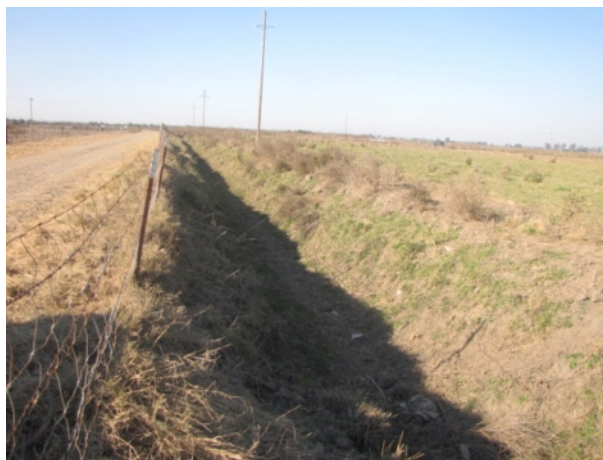
richard_s_20110215_077.jpg

Looking north at irrigation ditch along landside toe.

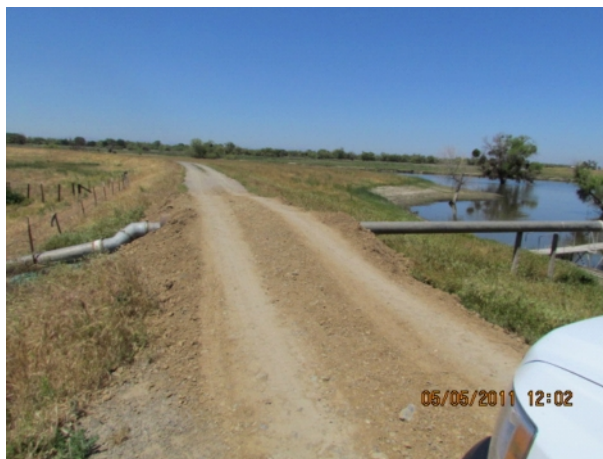
richard_s_20110510_533.jpg

Levee Mile Report Line	8
Start Levee Mile	19.33
End Levee Mile	19.33
Location	Crown
Category	Earthen Levee
Item	Encroachments

Looking north at unauthorized pipe across crown of levee with a ramp.

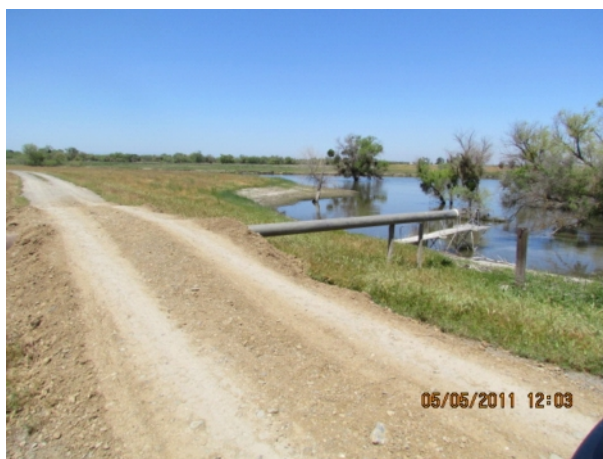
richard_s_20110510_534.jpg

Levee Mile Report Line	8
Start Levee Mile	19.33
End Levee Mile	19.33
Location	Crown
Category	Earthen Levee
Item	Encroachments

Looking northwest at pipe on waterside slope.

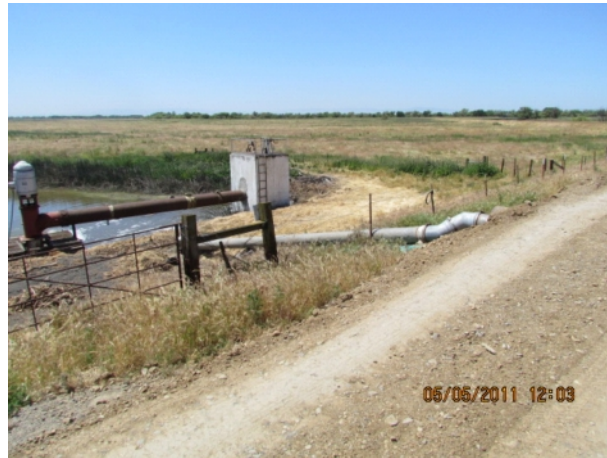
richard_s_20110510_535.jpg

Looking northeast at pipe on landside slope.

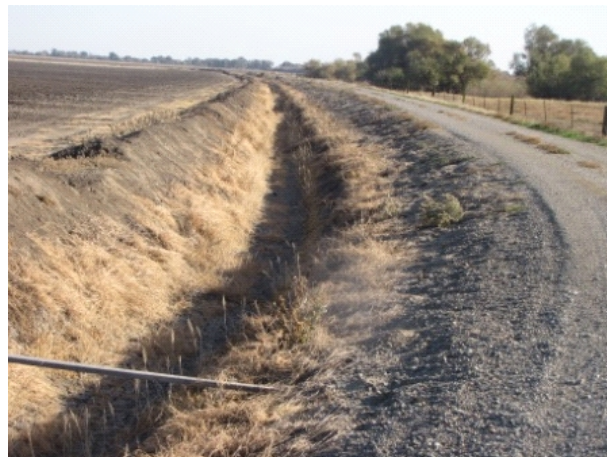
richard_s_20110215_078.jpg

Levee Mile Report Line	9
Start Levee Mile	22.09
End Levee Mile	22.56
Location	Land Side
Category	Earthen Levee
Item	Encroachments

Looking at landside ditch at levee toe.

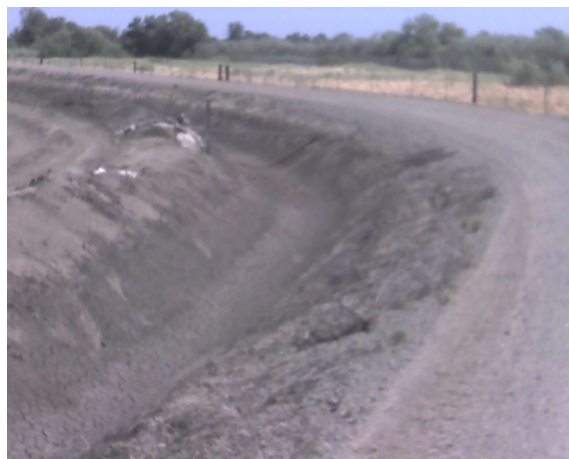
richard_s_20110215_079.jpg

Levee Mile Report Line	9
Start Levee Mile	22.09
End Levee Mile	22.56
Location	Land Side
Category	Earthen Levee
Item	Encroachments

Looking southeast at ditch along landside toe.

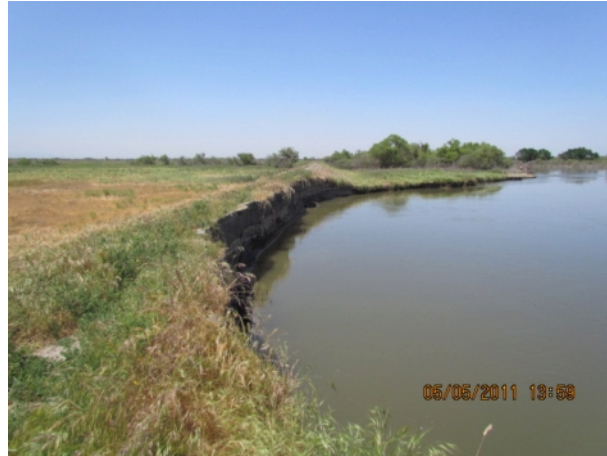
richard_s_20110510_538.jpg

Looking north erosion site.

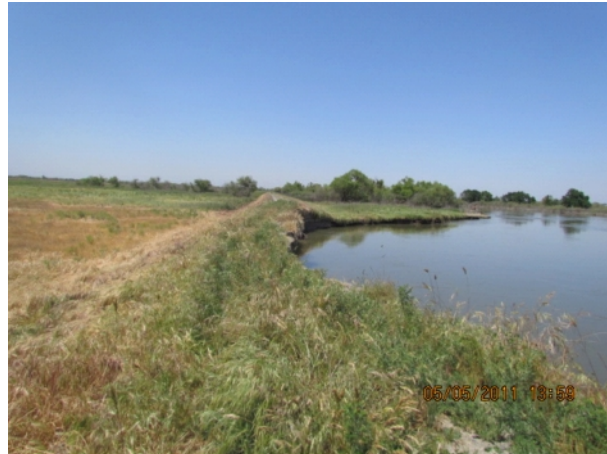
richard_s_20110510_539.jpg

Levee Mile Report Line	2
Start Levee Mile	0.77
End Levee Mile	0.77
Location	Water Side
Category	Earthen Levee
Item	Erosion / Bank Caving

Looking north at erosion extending to landside shoulder.

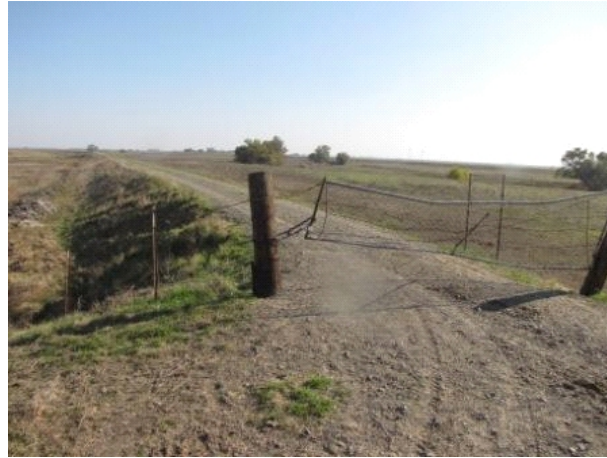
richard_s_20110215_083.jpg

Levee Mile Report Line	3
Start Levee Mile	6.58
End Levee Mile	6.58
Location	Crown
Category	Earthen Levee
Item	Repair Gates

Looking south at damage gate.

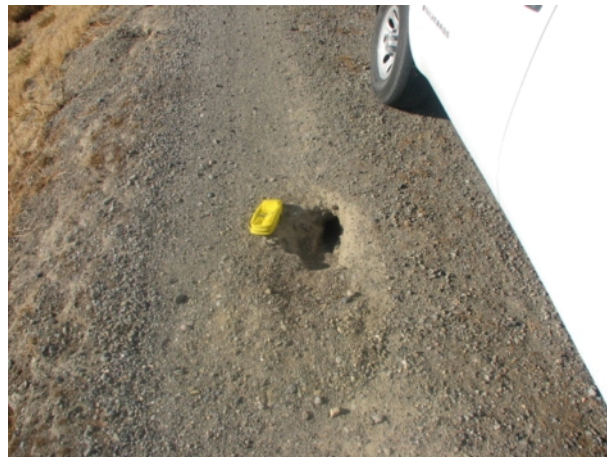
richard_s_20110215_084.jpg

Levee Mile Report Line	3
Start Levee Mile	4.67
End Levee Mile	4.67
Location	Crown
Category	Earthen Levee
Item	Animal Control

Looking at squirrel hole on crown of levee.

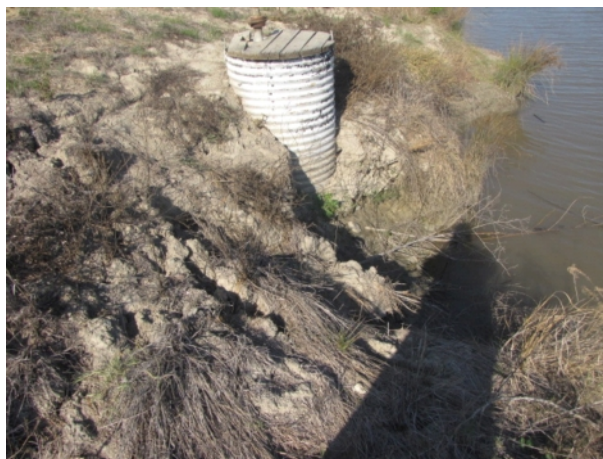
richard_s_20110215_093.jpg

Levee Mile Report Line	3
Start Levee Mile	0.10
End Levee Mile	0.10
Location	Water Side
Category	Earthen Levee
Item	Erosion / Bank Caving

Looking downstream at erosion around screw gate can on waterside slope.

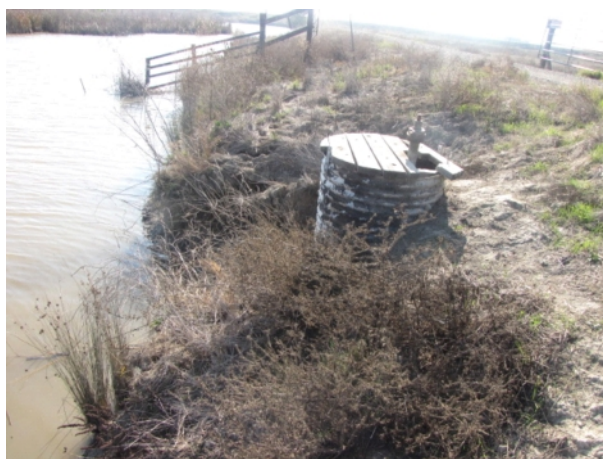
richard_s_20110215_094.jpg

Levee Mile Report Line	3
Start Levee Mile	0.10
End Levee Mile	0.10
Location	Water Side
Category	Earthen Levee
Item	Erosion / Bank Caving

Looking upstream at erosion around screw gate can.

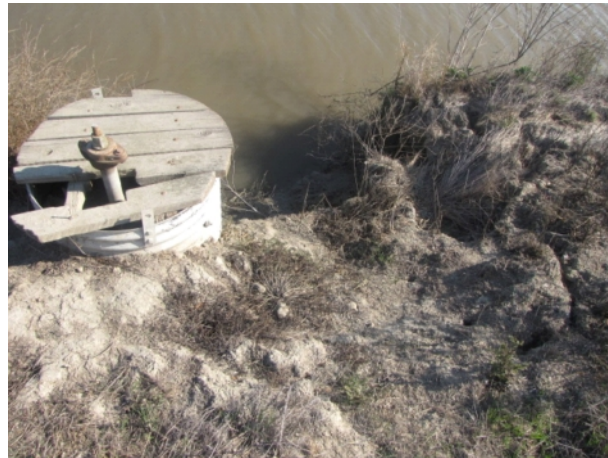
richard_s_20110215_095.jpg

Looking at erosion near and around screw gate can.

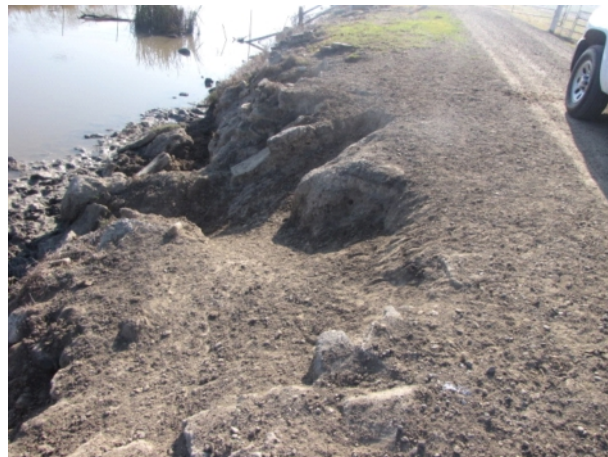
richard_s_20110215_085.jpg

Levee Mile Report Line	6
Start Levee Mile	3.65
End Levee Mile	3.65
Location	Water Side
Category	Earthen Levee
Item	Slope Stability

Looking upstream at one of several slope stability along canal.

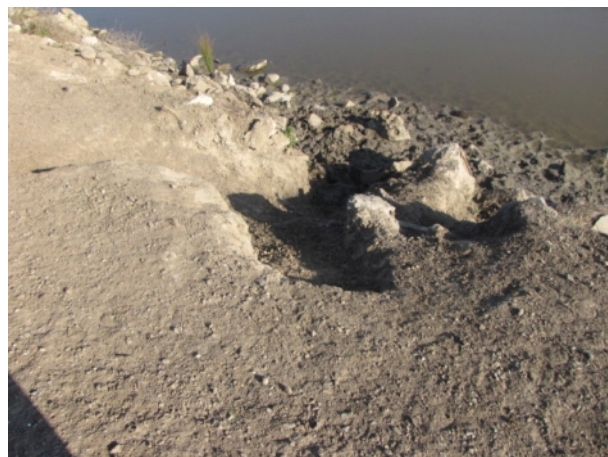
richard_s_20110215_086.jpg

Levee Mile Report Line	6
Start Levee Mile	3.65
End Levee Mile	3.65
Location	Water Side
Category	Earthen Levee
Item	Slope Stability

Looking at one of several slope stability along canal.

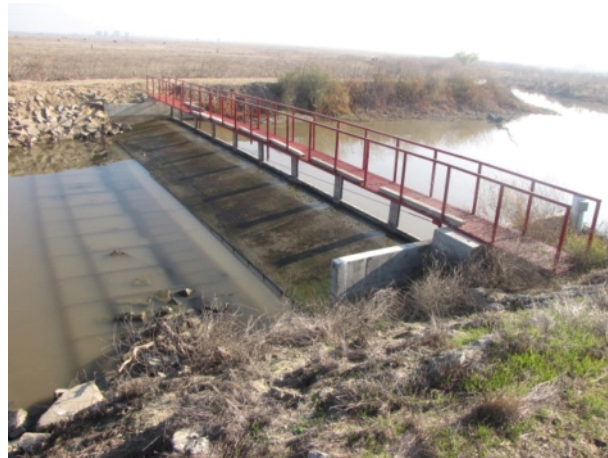
richard_s_20110215_090.jpg

Looking northeast at weir in channel.

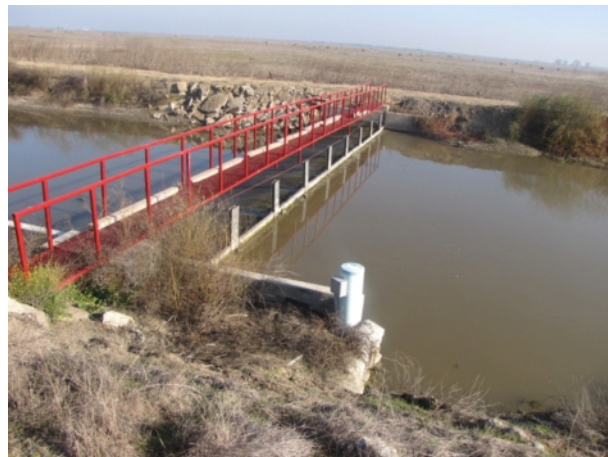
richard_s_20110215_091.jpg

Levee Mile Report Line	7
Start Levee Mile	3.85
End Levee Mile	3.85
Location	Water Side
Category	Channels
Item	Encroachments

Looking at upstream side of weir.

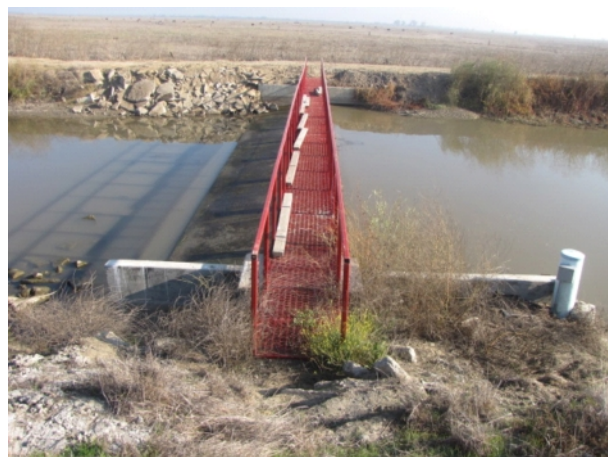
richard_s_20110215_092.jpg

Levee Mile Report Line	7
Start Levee Mile	3.85
End Levee Mile	3.85
Location	Water Side
Category	Channels
Item	Encroachments

Looking north at weir.

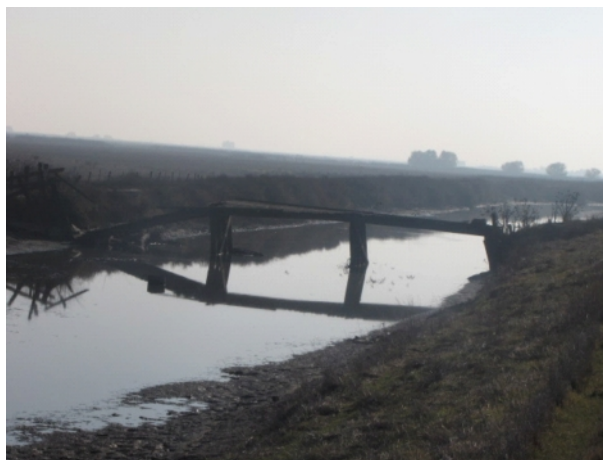
richard_s_20110215_087.jpg

Looking downstream at dilapidated bridge in channel.

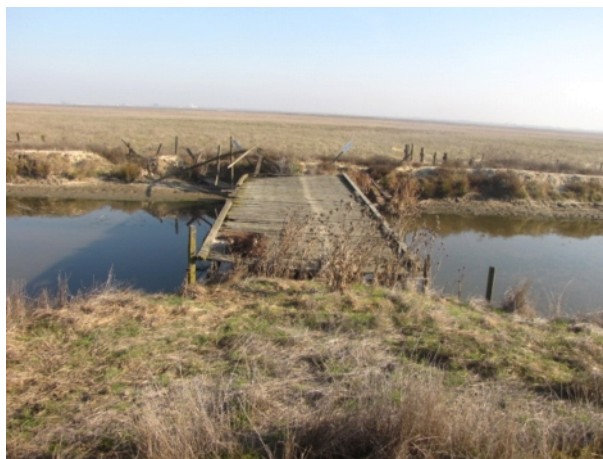
richard_s_20110215_088.jpg

Levee Mile Report Line	8
Start Levee Mile	4.68
End Levee Mile	4.68
Location	Water Side
Category	Channels
Item	Encroachments

Looking southeast at dilapidated bridge in channel.

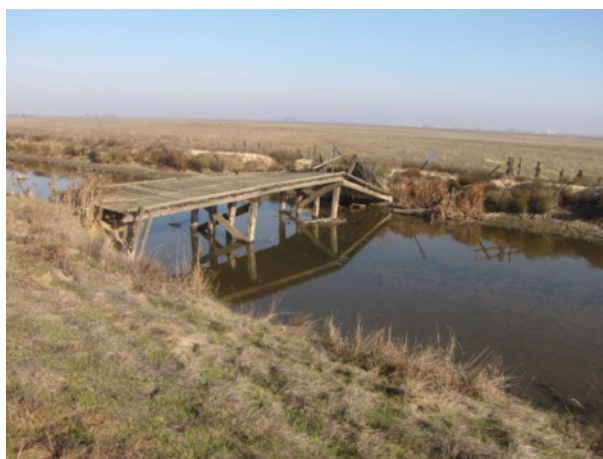
richard_s_20110215_089.jpg

Levee Mile Report Line	8
Start Levee Mile	4.68
End Levee Mile	4.68
Location	Water Side
Category	Channels
Item	Encroachments

Looking northeast at dilapidated bridge in channel.

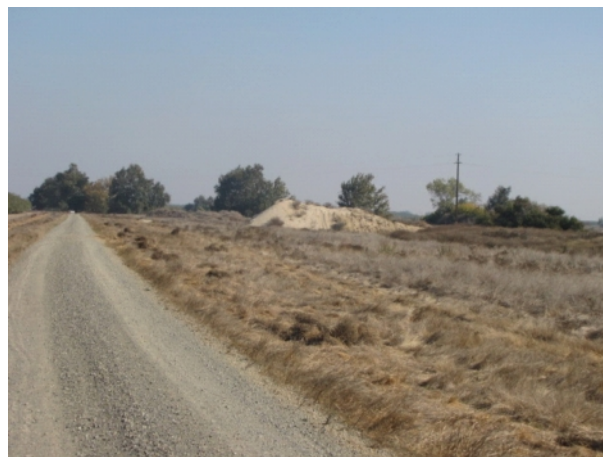
richard_s_20110215_096.jpg

Levee Mile Report Line	10
Start Levee Mile	5.23
End Levee Mile	5.23
Location	Water Side
Category	Earthen Levee
Item	Encroachments

Looking upstream (south) at sand pile within 100' of waterside levee toe.

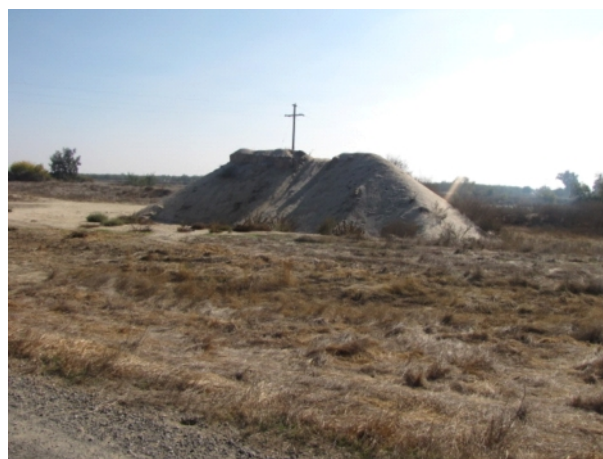
richard_s_20110215_097.jpg

Levee Mile Report Line	10
Start Levee Mile	5.23
End Levee Mile	5.23
Location	Water Side
Category	Earthen Levee
Item	Encroachments

Looking southwest at sand pile within 100' of waterside levee toe.

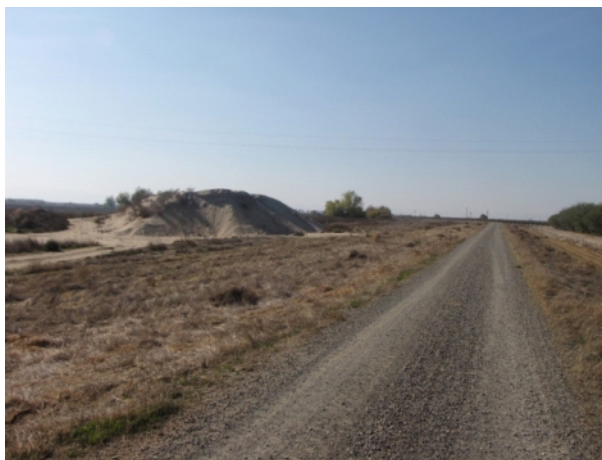
richard_s_20110215_098.jpg

Looking downstream (north) at sandpile within 100' of waterside levee toe.

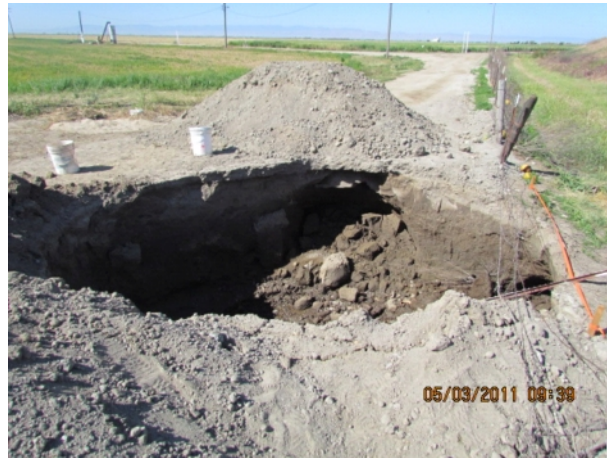
richard_s_20110524_002.jpg

Looking west at sink hole along farmer road and fence line.

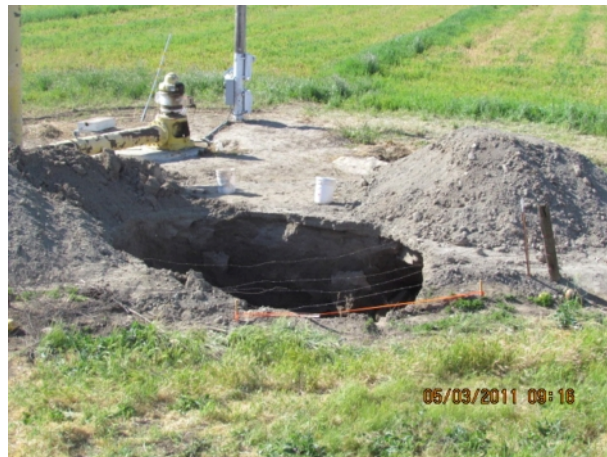
richard_s_20110531_003.jpg

Levee Mile Report Line	3
Start Levee Mile	1.75
End Levee Mile	1.75
Location	Land Side
Category	Earthen Levee
Item	Erosion / Bank Caving

Looking north at sink hole along fence line and farmer road.
